NOVEMBER 2018

Inspection report

“The Donjon”, **Gouda**
(NL)

Presentation of “the Donjon” solar plant

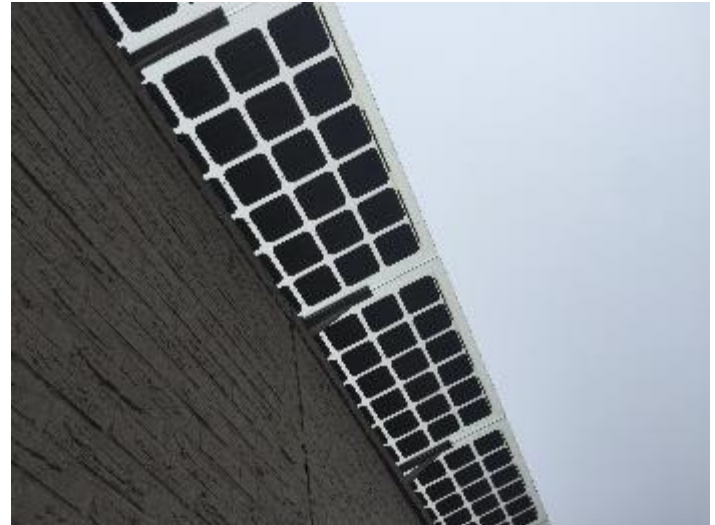
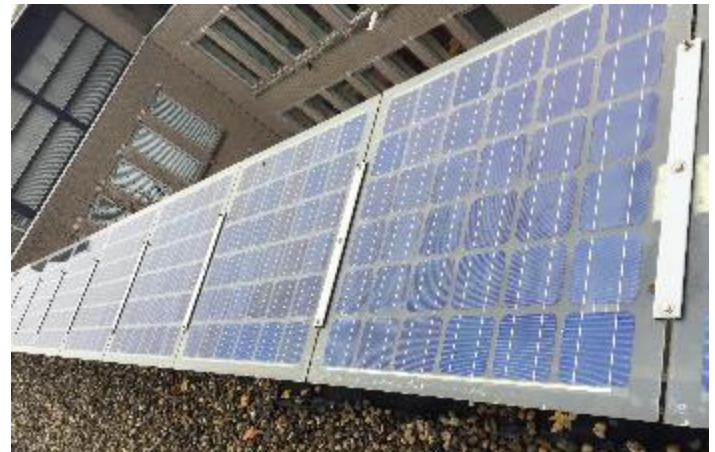
Cell ARC delamination (slight)

Affects 100% of panels

- This defect happens when the antireflective coating (ARC) comes off of the cell silicon surface.
- What does it look like?
 - The ARC makes the cell blue/black. When it comes off, the cell appears whiter/metallic.
- Why does it happen?
 - It can be the result of cell damage by impact or simply be a gradual process of delamination (usually alongside the busbar).
- How serious is it?
 - In itself, this is not a very serious defect unless there is a lot of delamination. But if it comes as a result of impact, then the cell damage itself may induce more serious problems.
- Remediation:
 - If the cells exhibits hot spots above 20°C, the panel should be replaced.
- Prevention:
 - The panel manufacturer should optimize the soldering process in order to avoid ARC delamination in operation.
 - Impact damage should be minimized during installation and maintenance procedures.

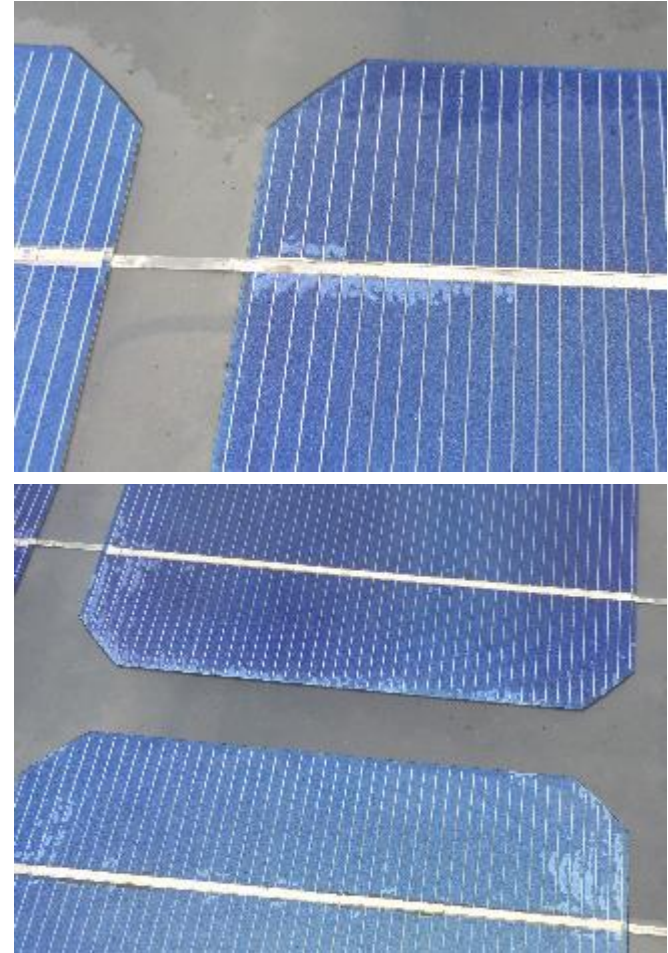
EVA yellowing (very slight)

Affects 100% of the panels on this installation

- EVA can be seen to yellow in the field.
- What does it look like?
 - The EVA yellows in front of the cells (rarely on the edges or the open space of permeable backsheets because the yellowing is usually also bleached by oxygen permeating through the backsheet).
- Why does it happen?
 - Poor cross linking.
 - Additives in the EVA formulation.
- How serious is it?
 - It can prevent some light from reaching the panel resulting in slight (maybe not even detectable at system level) power loss. NREL showed up to 5% power loss in very brown panels.
- Remediation:
 - The panels should be monitored for loss of power and signs of delamination.
- Prevention:
 - The panel manufacturer should use a reputable EVA supplier and ensure a minimum gel content of 70% after lamination.

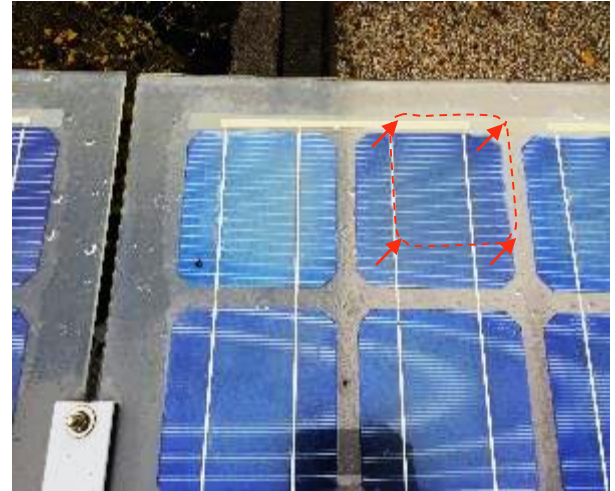
The EVA yellowing here is only very slight. The red outline is a little offset (direction of the red arrows) to show the area of yellowing. Broken cells would become visible because of the oxygen bleaching the yellowing out. We can conclude there are no broken cells on this installation

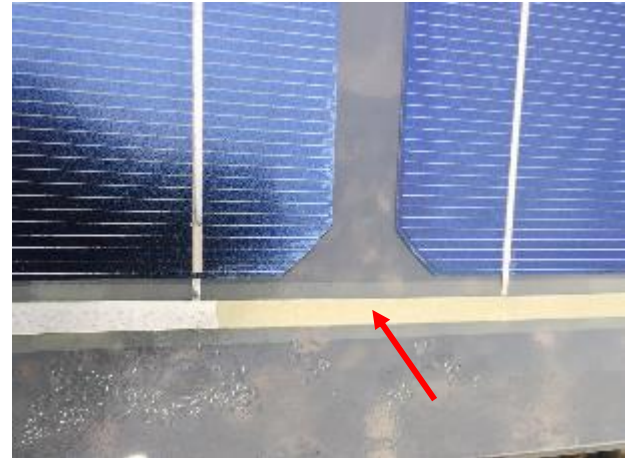
Backsheet yellowing (very slight)

- Backsheets can become yellow on the front or on the back of the panel (difficult to say which here).
- What does it look like?
 - The backsheet looks yellow over the whole surface of the panel or in specific areas (often hot spots).
- Why does it happen?
 - Some backsheets are UV sensitive and the yellowing is a sign of this sensitive. Temperature can accelerate this degradation.
 - Some backsheets will also suffer yellowing as a result of thermal degradation.
- How serious is it?
 - Yellowing is often associated with worsening mechanical properties. Eventually, the backsheet might delaminate and/or crack.
- Remediation:
 - Continue monitoring the backsheet for cracking and/or delamination.
- Prevention:
 - The panel manufacturer should use backsheet components with high UV and temperature resistance and UV filtering capabilities

The backsheet yellowing here is only visible where there is a double thickness of backsheet, i.e. where a strip of backsheet was used as an insulating insert to fold the solder ribbons back towards the junction box.

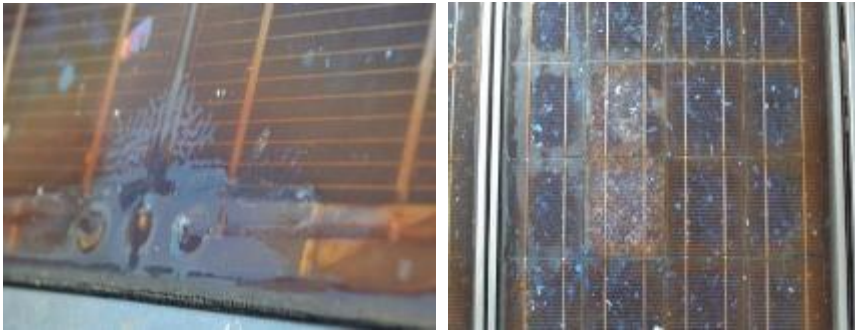
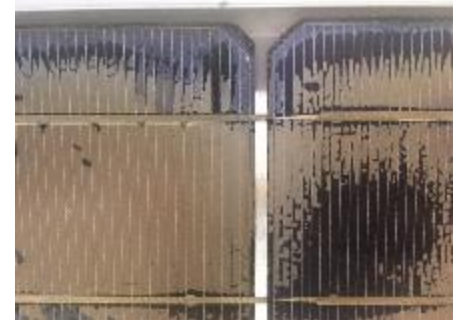
- Glass traps acetic acid
 - Glass is incapable of preventing moisture ingress from edges³, acetic acid is generated
 - Acetic acid then corrodes cell interconnects, increases resistance, and reduces power

Glass-glass modules with busbar corrosion-
Danzhou, China, 15 years

Bus bar corrosion, delamination, and
EVA browning in JRC glass-glass
modules

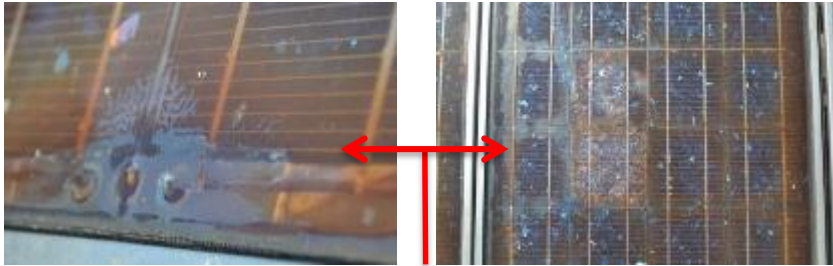
Observation: Bus bar Corrosion, EVA browning
Power loss
Location: Danzhou (China), Time: 15 years

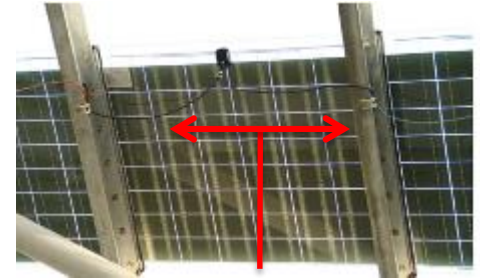
Observation: Bus Bar Corrosion,
Power loss
Location: Okinawa (Japan), Time: 11 yrs

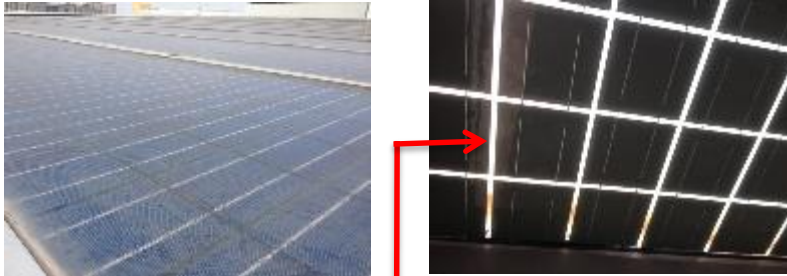
Observation: Bus bar Corrosion
Power loss
Location: Shanghai (China), Time: 5 years

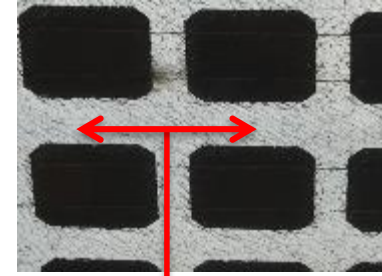
Observation: Extensive breakage
Location: Yannan (China), Time: 10 yrs
