NOVEMBER 2018

Inspection report

“The Donjon”, **Gouda**
(NL)

Presentation of “the Donjon” solar plant

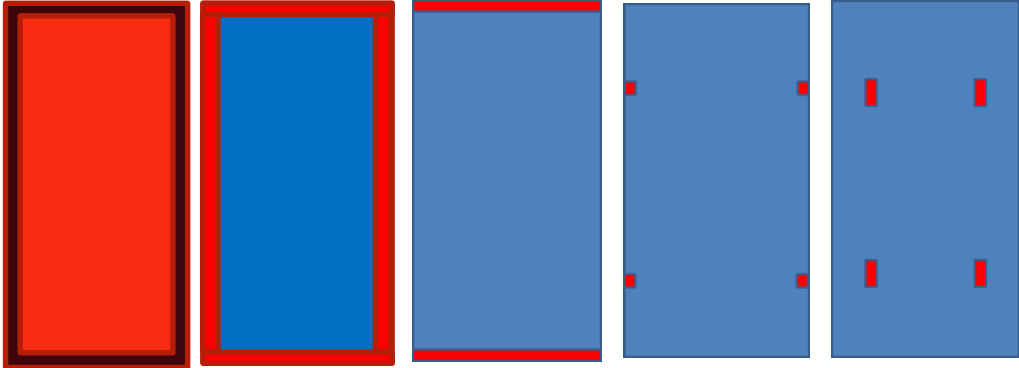
$\Delta P(\max)$ as %	Regulatory Source	G/Tedlar	G/Glass	G/Glass	G/Glass	G/Glass
Stress			4-Edge	2-Edge	Side Clips	Back Clips
50C/85% Foil Face	Pre 2015 IEC Option 1	0	0			
60C/85% RH	Pre 2015 IEC Option 2	-0.5	-6.7			
85C/85% RH						
120 hrs		-1.2	-28.8			
96 hrs	Post 2015 IEC minimum and "China" recommended			-10.6	0	-6.3
192 hrs	2 x "China"			-14.5	-1.9	-17.6

Glass / Glass Modules show power loss and fail PID tests with different mounting configurations
